**Flood Control Project Maintenance  
Levee Inspections****LMA District Cover Sheet  
Spring 2015 Levee Inspection Results****American River Flood Control District**

**Spring 2015 Levee Inspection Results**

**American River Flood Control District**

Waterway			Bank	Unit Miles
Unit No. 01 Arcade Creek			Left	2.08
	Spring (March - May)	Summer (June - August)	(September - November) Fall	Winter (December - February)
Unit Maintenance Rating (Fall Only)				
Date of Inspection	04/30/2015 - 04/30/2015			
DWR Inspector	Maksim Khashchuk			
Accompanied By	Richard Marck ARFCD

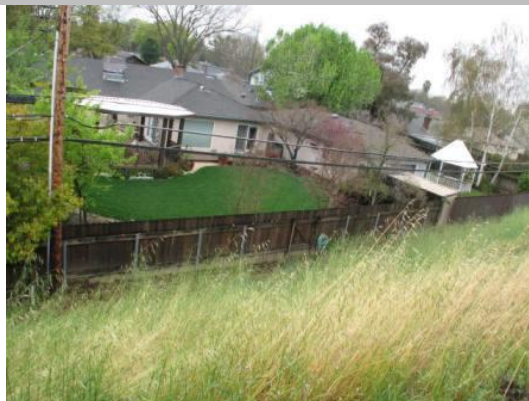
Photo 1 of 1 : SP\_2015\_NA0001\_55\_191\_20150317\_00165.jpg

LM Start	4.21	Rating **	U	Issue No.	191
LM End	4.21	Issue Type +	En	Location *	LS
Category	Earthen Levee			GPS Latitude/Longitude	
				Start	End
Item	Encroachments			38.583355 °	38.583355 °
				-121.443123 °	-121.443123 °
DWR ID	DWR_NA0001_04_s_2012_191				
Action/Comments					
Fence					
Inspector Comments: Wooden privacy fence within 10-ft of the levee toe obstruct access and visibility.

03/16/2012 Wood privacy fence completely obstructs access and visibility.

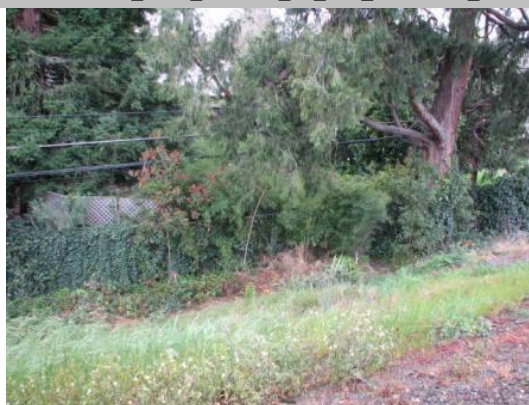
Photo 1 of 1 : SP\_2015\_NA0001\_55\_192\_20150317\_00166.jpg

LM Start	4.25	Rating **	U	Issue No.	192
LM End	4.25	Issue Type +	En	Location *	LS
Category	Earthen Levee			GPS Latitude/Longitude	
				Start	End
Item	Vegetation			38.583031 °	38.583031 °
				-121.442620 °	-121.442620 °
DWR ID	DWR_NA0001_04_s_2012_192				
Action/Comments					
Landscaping					
Inspector Comments: Ivy and vine growth on cyclone fence obstruct visibility. Steps and landscaping built up levee slope.

03/16/2012 Landscaping on fence obstructs visibility and access.

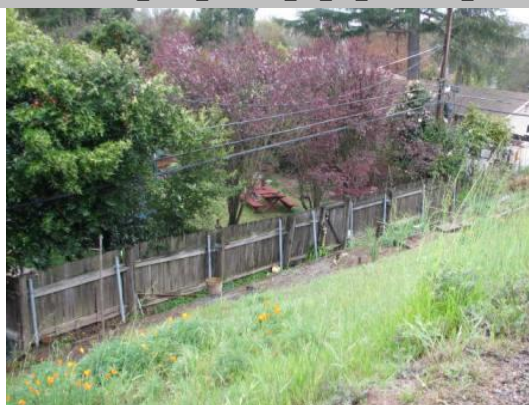
Photo 1 of 1 : SP\_2015\_NA0001\_55\_26\_20150317\_00025.jpg

LM Start	4.31	Rating **	U	Issue No.	26
LM End	4.31	Issue Type +	En	Location *	LS
Category	Earthen Levee			GPS Latitude/Longitude	
				Start	End
Item	Encroachments			38.582479 °	38.582479 °
				-121.441768 °	-121.441768 °
DWR ID	DWR_NA0001_04_s_2012_26				
Action/Comments					
Fence					
Inspector Comments: Wooden fence within 10-ft of the levee toe.					
Garden and ramp built on levee slope.

03/16/2012 Wood privacy fence completely obstructs access and visibility.

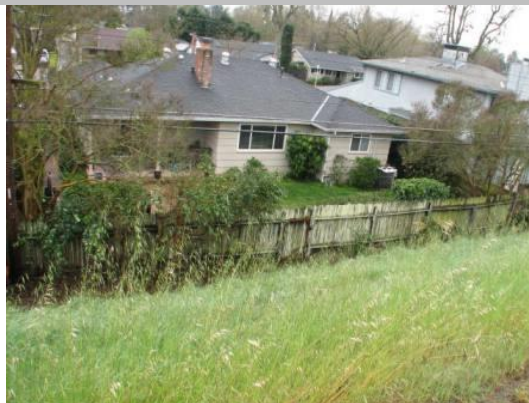
Photo 1 of 1 : SP\_2015\_NA0001\_55\_198\_20150317\_00170.jpg

LM Start	4.41	Rating **	U	Issue No.	198
LM End	4.41	Issue Type +	En	Location *	LS
Category	Earthen Levee			GPS Latitude/Longitude	
				Start	End
Item	Encroachments			38.581788 °	38.581788 °
				-121.440086 °	-121.440086 °
DWR ID	DWR_NA0001_04_s _ 2012_198				
Action/Comments					
Fence					
Inspector Comments: Privacy fence and landscaping within 10-ft of the levee toe obstruct access and visibility.

03/16/2012 Wood privacy fence completely obstructs access and visibility.

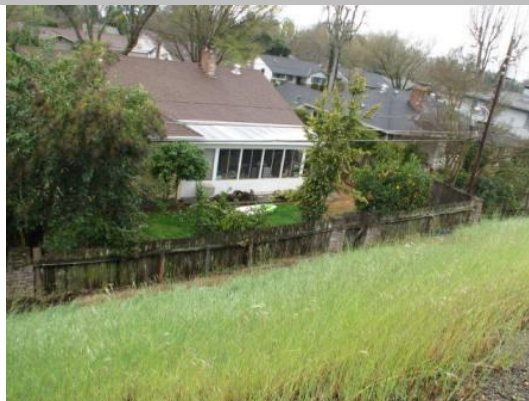
Photo 1 of 1 : SP\_2015\_NA0001\_55\_30\_20150317\_00029.jpg

LM Start	4.42	Rating **	U	Issue No.	30
LM End	4.42	Issue Type +	En	Location *	LS
Category	Earthen Levee			GPS Latitude/Longitude	
				Start	End
Item	Encroachments			38.581724 °	38.581724 °
				-121.439891 °	-121.439891 °
DWR ID	DWR_NA0001_04_s _ 2012_30				
Action/Comments					
Fence					
Inspector Comments: Privacy fence and landscaping within 10-ft of the levee toe obstruct access and visibility.

03/16/2012 Wood privacy fence completely obstructs access and visibility.

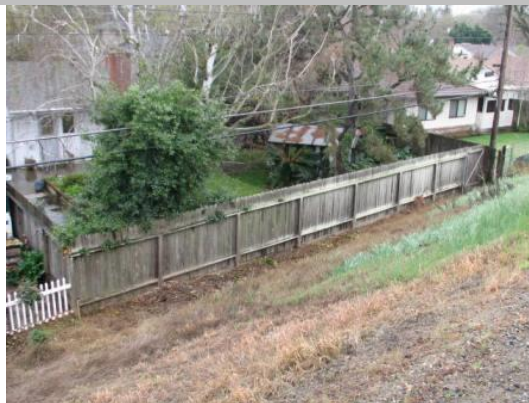
Photo 1 of 1 : SP\_2015\_NA0001\_55\_31\_20150317\_00030.jpg

LM Start	4.47	Rating **	U	Issue No.	31
LM End	4.47	Issue Type +	En	Location *	LS
Category	Earthen Levee			GPS Latitude/Longitude	
				Start	End
Item	Encroachments			38.581495 °	38.581495 °
				-121.439129 °	-121.439129 °
DWR ID	DWR_NA0001_04_s _ 2012_31				
Action/Comments					
Fence					
Inspector Comments: Privacy fence within 10-ft of the levee toe obstructs access and visibility.

03/16/2012 Wood privacy fence completely obstructs access and visibility.

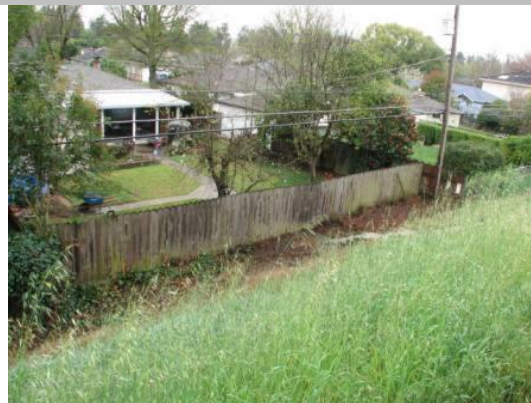
Photo 1 of 1 : SP\_2015\_NA0001\_55\_35\_20150317\_00031.jpg

LM Start	4.53	Rating **	U	Issue No.	35
LM End	4.53	Issue Type +	En	Location *	LS
Category	Earthen Levee			GPS Latitude/Longitude	
				Start	End
Item	Encroachments			38.581246 °	38.581246 °
				-121.438033 °	-121.438033 °
DWR ID	DWR_NA0001_04_s_2012_35				
Action/Comments					
Fence					
Inspector Comments: Wooden fence within 10-ft of the levee toe obstructs access and visibility.

03/16/2012 Wood privacy fence completely obstructs access and visibility.

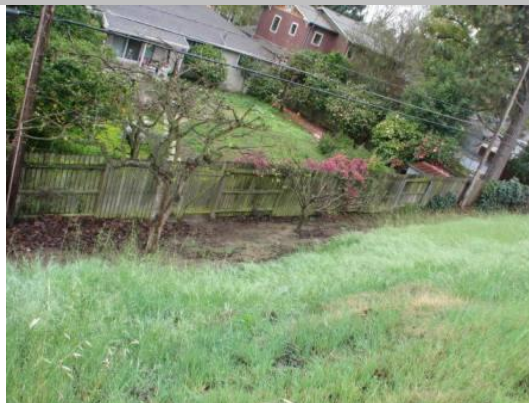
Photo 1 of 1 : SP\_2015\_NA0001\_55\_200\_20150317\_00172.jpg

LM Start	4.55	Rating **	U	Issue No.	200
LM End	4.55	Issue Type +	En	Location *	LS
Category	Earthen Levee			GPS Latitude/Longitude	
				Start	End
Item	Encroachments			38.581178 °	38.581178 °
				-121.437584 °	-121.437584 °
DWR ID	DWR_NA0001_04_s _ 2012_200				
Action/Comments					
Fence					
Inspector Comments: Privacy fence, persimmon tree and landscaping within 10-ft of the levee toe obstruct access and visibility.

03/16/2012 Wood privacy fence completely obstructs access and visibility.

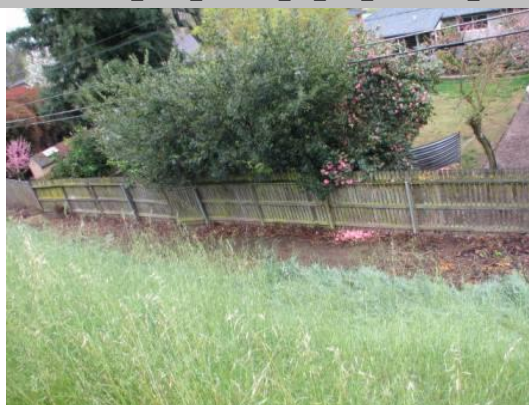
Photo 1 of 1 : SP\_2015\_NA0001\_55\_201\_20150317\_00173.jpg

LM Start	4.57	Rating **	U	Issue No.	201
LM End	4.57	Issue Type +	En	Location *	LS
Category	Earthen Levee			GPS Latitude/Longitude	
				Start	End
Item	Encroachments			38.581155 °	38.581155 °
				-121.437320 °	-121.437320 °
DWR ID	DWR_NA0001_04_s _ 2012_201				
Action/Comments					
Fence					
Inspector Comments: Privacy fence within 10-ft of the levee toe obstruct access and visibility.

03/16/2012 Wood privacy fence completely obstructs access and visibility.

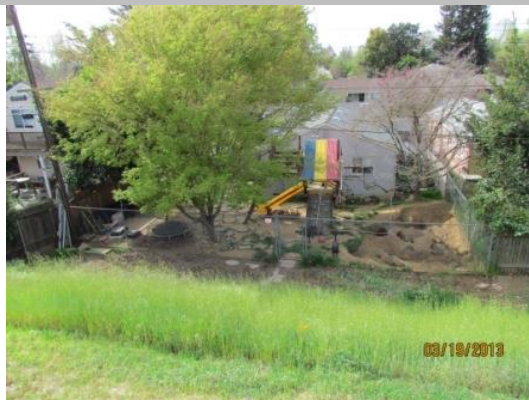
Photo 1 of 2 : SP\_2015\_NA0001\_55\_739\_20150317\_00194.jpg

LM Start	4.72	Rating **	M	Issue No.	739
LM End	4.72	Issue Type +	En	Location *	LS
Category	Earthen Levee			GPS Latitude/Longitude	
				Start	End
Item	Encroachments			38.580778 °	38.580778 °
				-121.434467 °	-121.434467 °
DWR ID	DWR_NA0001_04_s _ 2012_739				
Action/Comments					
Debris					
Inspector Comments: PVC pipe and debris, also noted in USACE PI.

View of the previously noted debris stored in the upstream corner of the property. Note extensive burrowing in the backyard on the downstream (right) corner of the property.

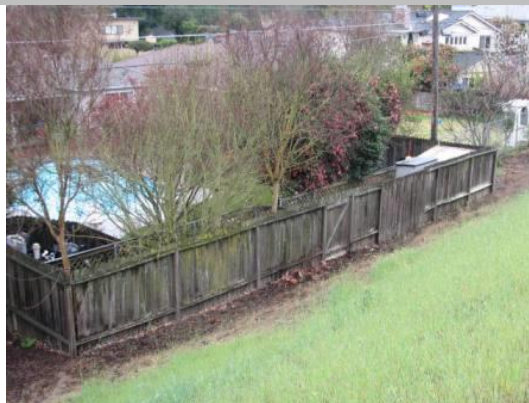
Photo 1 of 1 : SP\_2015\_NA0001\_55\_43\_20150317\_00034.jpg

LM Start	4.78	Rating **	U	Issue No.	43
LM End	4.78	Issue Type +	En	Location *	LS
Category	Earthen Levee			GPS Latitude/Longitude	
				Start	End
Item	Encroachments			38.580731 °	38.580731 °
				-121.433490 °	-121.433490 °
DWR ID	DWR_NA0001_04_s _ 2012_43				
Action/Comments					
Fence					
Inspector Comments: Privacy fence and storage sheds within 10-ft of the levee toe obstruct access and visibility.

03/16/2012 Wood privacy fence completely obstructs access and visibility.

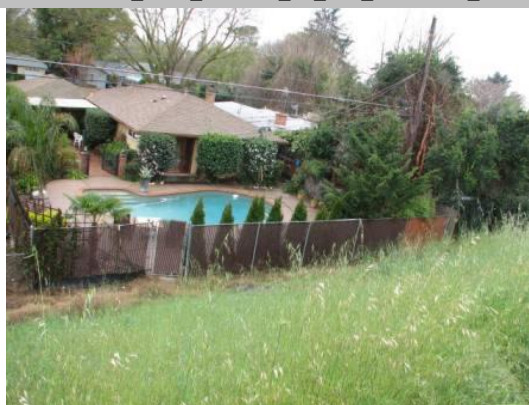
Photo 1 of 1 : SP\_2015\_NA0001\_55\_205\_20150317\_00176.jpg

LM Start	4.83	Rating **	U	Issue No.	205
LM End	4.83	Issue Type +	En	Location *	LS
Category	Earthen Levee			GPS Latitude/Longitude	
				Start	End
Item	Encroachments			38.580723 °	38.580723 °
				-121.432577 °	-121.432577 °
DWR ID	DWR_NA0001_04_s _ 2012_205				
Action/Comments					
Fence					
Inspector Comments: Privacy fence and landscape prunings on levee slope and toe.prunings removed. Fence obstructs access and visibility.

03/16/2012 Chainlink fence with privacy slats obstructs visibility and access.

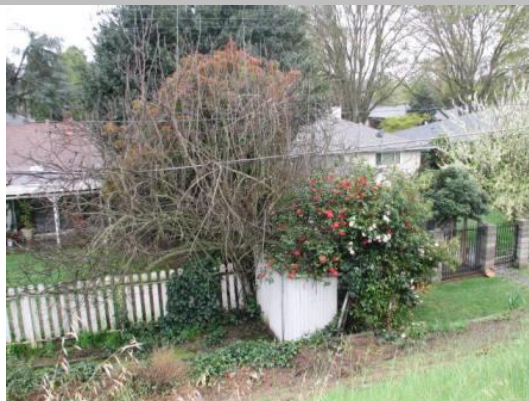
Photo 1 of 1 : SP\_2015\_NA0001\_55\_206\_20150317\_00177.jpg

LM Start	4.87	Rating **	U	Issue No.	206
LM End	4.87	Issue Type +	En	Location *	LS
Category	Earthen Levee			GPS Latitude/Longitude	
				Start	End
Item	Vegetation			38.580778 °	38.580778 °
				-121.431704 °	-121.431704 °
DWR ID	DWR_NA0001_04_s _ 2012_206				
Action/Comments					
Landscaping					
Inspector Comments: Fig tree obstructs visibility and access.

03/16/2012 Landscaping obstructs visibility and access.

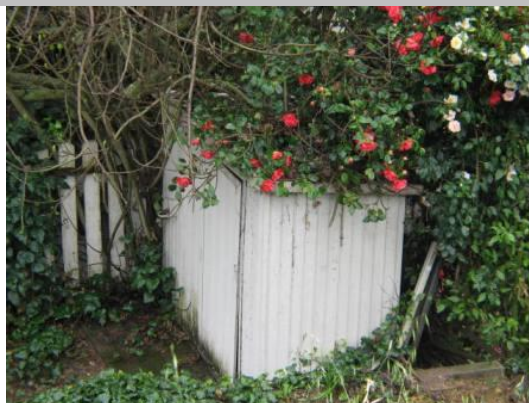
Photo 1 of 1 : SP\_2015\_NA0001\_55\_96\_20150317\_00079.jpg

LM Start	4.87	Rating **	U	Issue No.	96
LM End	4.87	Issue Type +	En	Location *	LS
Category	Earthen Levee			GPS Latitude/Longitude	
				Start	End
Item	Encroachments			38.580767 °	38.580767 °
				-121.431684 °	-121.431684 °
DWR ID	DWR_NA0001_04_s _ 2012_96				
Action/Comments					
Building Inspector Comments: Wooden shed is located beneath the fig tree.

3/16/2012 Structure is within 15' of levee toe.

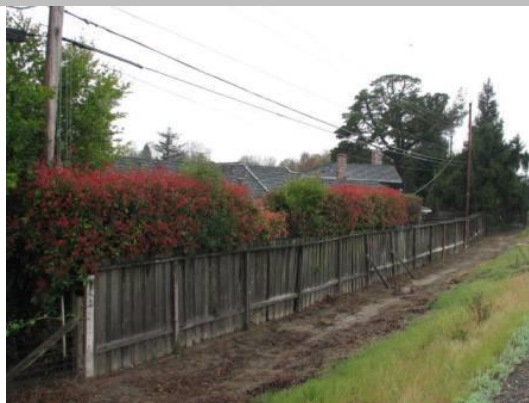
Photo 1 of 1 : SP\_2015\_NA0001\_55\_46\_20150317\_00036.jpg

LM Start	5.08	Rating **	U	Issue No.	46
LM End	5.08	Issue Type +	En	Location *	LS
Category	Earthen Levee			GPS Latitude/Longitude	
				Start	End
Item	Encroachments			38.581001 °	38.581001 °
				-121.427854 °	-121.427854 °
DWR ID	DWR_NA0001_04_s_2012_46				
Action/Comments					
Fence					
Inspector Comments: Privacy fence and landscaping within 10-ft of the levee toe obstruct access and visibility.

03/16/2012 Wood privacy fence completely obstructs access and visibility.

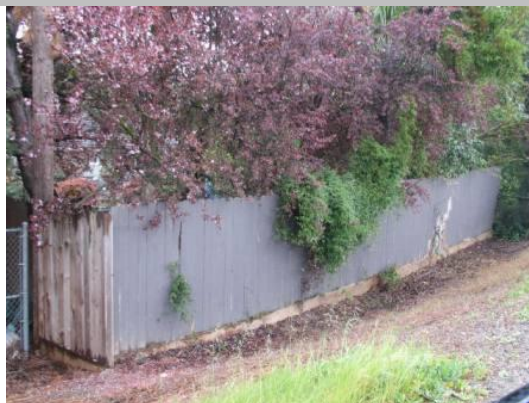
Photo 1 of 1 : SP\_2015\_NA0001\_55\_48\_20150317\_00038.jpg

LM Start	5.17	Rating **	U	Issue No.	48
LM End	5.17	Issue Type +	En	Location *	LS
Category	Earthen Levee			GPS Latitude/Longitude	
				Start	End
Item	Encroachments			38.580622 °	38.580622 °
				-121.426372 °	-121.426372 °
DWR ID	DWR_NA0001_04_s _ 2012_48				
Action/Comments					
Fence					
Inspector Comments: Wood privacy fence and landscaping within 10-ft of the levee toe obstruct access and visibility.

03/16/2012 Wood privacy fence completely obstructs access and visibility.

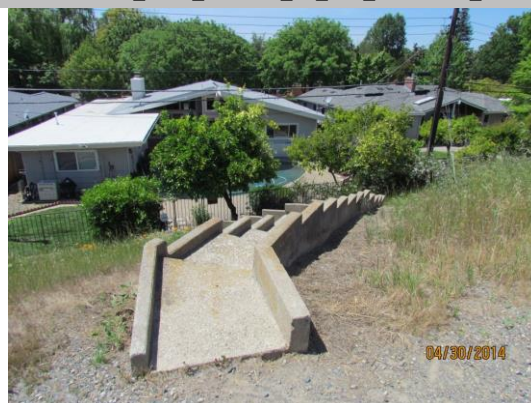
Photo 1 of 1 : SP\_2015\_NA0001\_55\_197\_20150317\_00169.jpg

LM Start	5.56	Rating **	U	Issue No.	197
LM End	5.56	Issue Type +	En	Location *	LS
Category	Earthen Levee			GPS Latitude/Longitude	
				Start	End
Item	Encroachments			38.575887 °	38.575887 °
				-121.423113 °	-121.423113 °
DWR ID	DWR_NA0001_04_s _ 2013_197				
Action/Comments					
Stairway					
Inspector Comments: Unpermitted stairs to be removed by ARFCD.

View of the stairs on the landside levee slope.

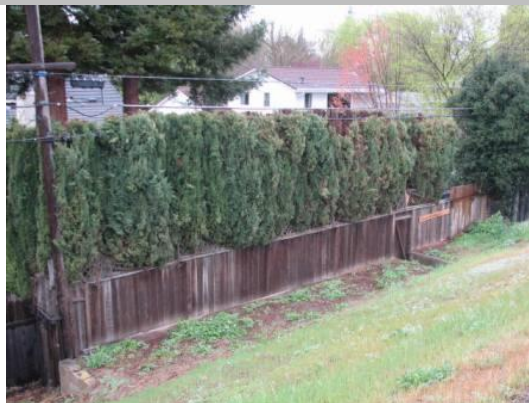
Photo 1 of 1 : SP\_2015\_NA0001\_55\_53\_20150317\_00042.jpg

LM Start	5.61	Rating **	U	Issue No.	53
LM End	5.61	Issue Type +	En	Location *	LS
Category	Earthen Levee			GPS Latitude/Longitude	
				Start	End
Item	Vegetation			38.575250 °	38.575250 °
				-121.423240 °	-121.423240 °
DWR ID	DWR_NA0001_04_s _ 2012_53				
Action/Comments					
Landscaping					
Inspector Comments: Wood privacy fence, helix sky pencil, vines and landscaping within 10-ft of the levee toe obstruct access and visibility.					
Cement stairs up levee slope.

03/16/2012 Landscaping and fence obstruct visibility and access.

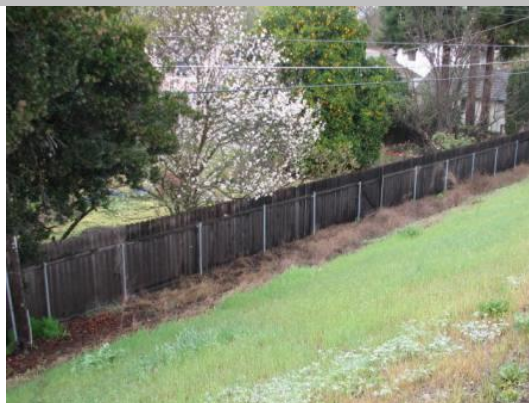
Photo 1 of 1 : SP\_2015\_NA0001\_55\_54\_20150317\_00043.jpg

LM Start	5.62	Rating **	U	Issue No.	54
LM End	5.62	Issue Type +	En	Location *	LS
Category	Earthen Levee			GPS Latitude/Longitude	
				Start	End
Item	Encroachments			38.575093 °	38.575093 °
				-121.423263 °	-121.423263 °
DWR ID	DWR_NA0001_04_s _ 2012_54				
Action/Comments					
Fence					
Inspector Comments: Wood privacy fence and landscaping within 10-ft of the levee toe obstruct access and visibility.

03/16/2012 Wood privacy fence completely obstructs access and visibility.

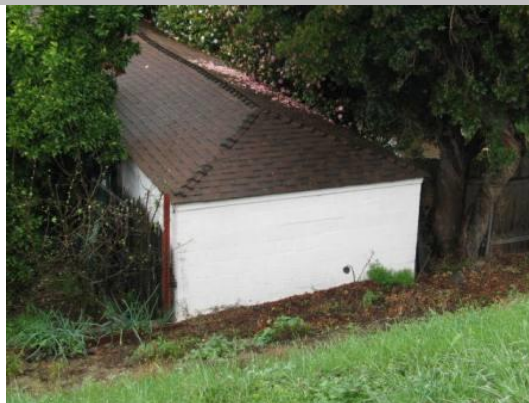
Photo 1 of 1 : SP\_2015\_NA0001\_55\_56\_20150317\_00045.jpg

LM Start	5.65	Rating **	U	Issue No.	56
LM End	5.65	Issue Type +	En	Location *	LS
Category	Earthen Levee			GPS Latitude/Longitude	
				Start	End
Item	Encroachments			38.574648 °	38.574648 °
				-121.423348 °	-121.423348 °
DWR ID	DWR_NA0001_04_s_2012_56				
Action/Comments					
Building Inspector Comments: Cement block building on levee slope obstructs access.

03/16/2012 Structure within 15' of levee toe.

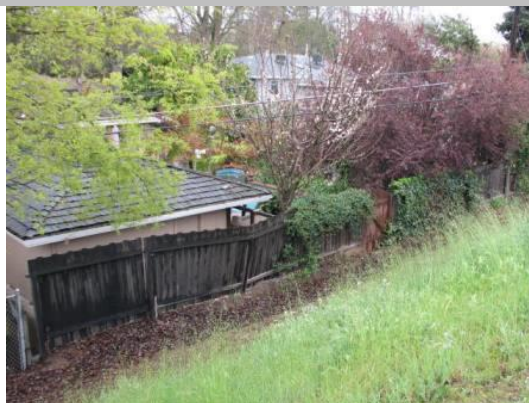
Photo 1 of 1 : SP\_2015\_NA0001\_55\_57\_20150317\_00046.jpg

LM Start	5.70	Rating **	U	Issue No.	57
LM End	5.70	Issue Type +	En	Location *	LS
Category	Earthen Levee			GPS Latitude/Longitude	
				Start	End
Item	Encroachments			38.573927 °	38.573927 °
				-121.423480 °	-121.423480 °
DWR ID	DWR_NA0001_04_s_2012_57				
Action/Comments					
Fence					
Inspector Comments: Wood privacy fence with ivy obstructs visibility.

03/16/2012 Wood privacy fence completely obstructs access and visibility.

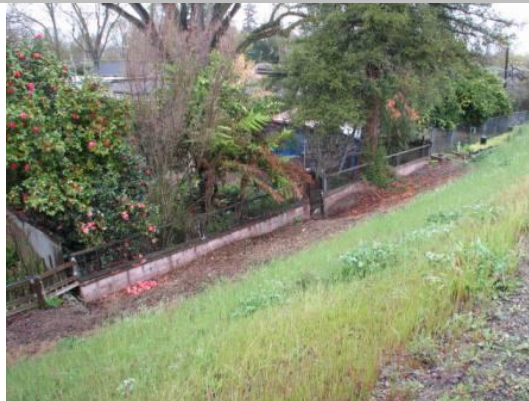
Photo 1 of 1 : SP\_2015\_NA0001\_55\_59\_20150317\_00047.jpg

LM Start	5.73	Rating **	U	Issue No.	59
LM End	5.73	Issue Type +	En	Location *	LS
Category	Earthen Levee			GPS Latitude/Longitude	
				Start	End
Item	Encroachments			38.573403 °	38.573403 °
				-121.423642 °	-121.423642 °
DWR ID	DWR_NA0001_04_s _ 2012_59				
Action/Comments					
Fence					
Inspector Comments: Brick fence and landscaping within 10-ft of the levee toe obstructs access and visibility.

03/16/2012 Fence and landscaping obstruct visibility and access.

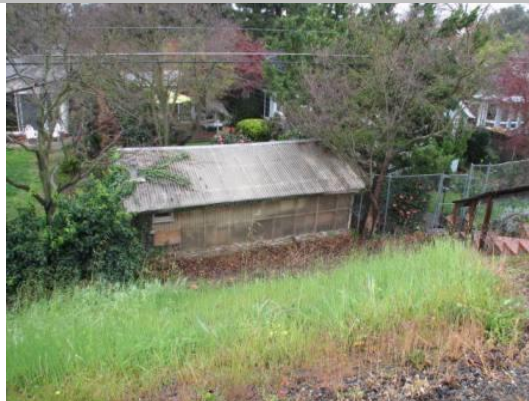
Photo 1 of 1 : SP\_2015\_NA0001\_55\_63\_20150317\_00049.jpg

LM Start	5.81	Rating **	U	Issue No.	63
LM End	5.81	Issue Type +	En	Location *	LS
Category	Earthen Levee			GPS Latitude/Longitude	
				Start	End
Item	Encroachments			38.572325 °	38.572325 °
				-121.423913 °	-121.423913 °
DWR ID	DWR_NA0001_04_s _ 2012_63				
Action/Comments					
Building Inspector Comments: Wood and fiberglass structure within 10-ft of the levee toe.

03/16/2012 Wood and fiberglass structure is within 15' of levee toe.

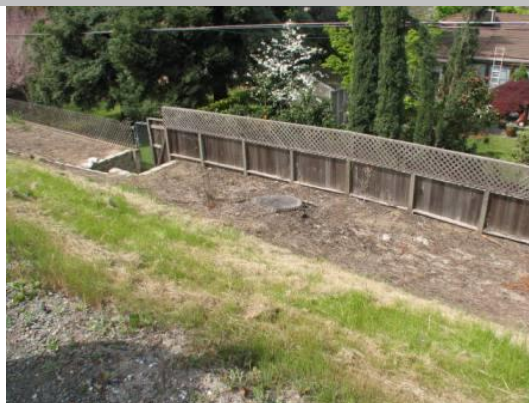
Photo 1 of 1 : SP\_2015\_NA0001\_55\_181\_20150317\_00159.jpg

LM Start	5.83	Rating **	N	Issue No.	181
LM End	5.83	Issue Type +	Ma	Location *	LS
Category	Earthen Levee			GPS Latitude/Longitude	
				Start	End
Item	Trim / Thin Trees			38.572032 °	38.572032 °
				-121.423981 °	-121.423981 °
DWR ID	DWR_NA0001_04_s_2012_181				
Action/Comments					
Tree stumps.					
Inspector Comments: 04/14/2011 Large stump at toe of levee.

04/14/2011 Large stump at toe of levee.

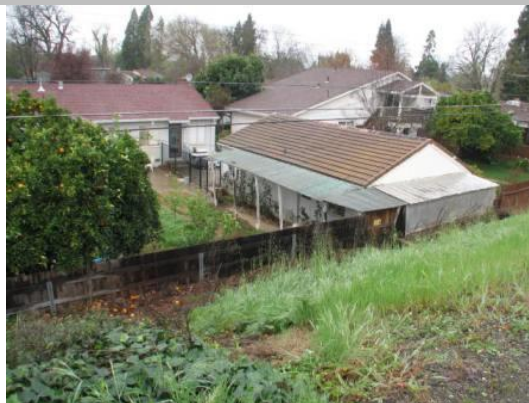
Photo 1 of 1 : SP\_2015\_NA0001\_55\_66\_20150317\_00051.jpg

LM Start	5.86	Rating **	U	Issue No.	66
LM End	5.86	Issue Type +	En	Location *	LS
Category	Earthen Levee			GPS Latitude/Longitude	
				Start	End
Item	Encroachments			38.571586 °	38.571586 °
				-121.424097 °	-121.424097 °
DWR ID	DWR_NA0001_04_s_2012_66				
Action/Comments					
Building

03/16/2012 Structure is within 15' of levee toe.

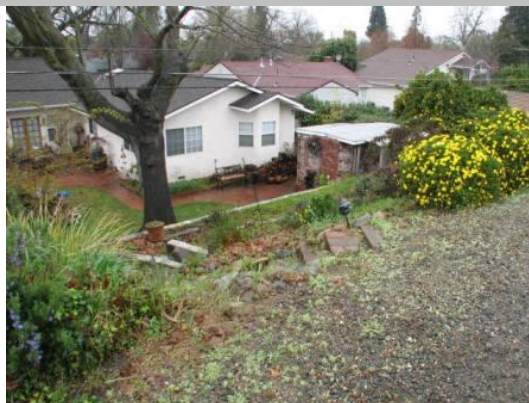
Photo 1 of 1 : SP\_2015\_NA0001\_55\_68\_20150317\_00053.jpg

LM Start	5.87	Rating **	U	Issue No.	68
LM End	5.87	Issue Type +	En	Location *	LS
Category	Earthen Levee			GPS Latitude/Longitude	
				Start	End
Item	Vegetation			38.571525 °	38.571525 °
				-121.424152 °	-121.424152 °
DWR ID	DWR_NA0001_04_f_2013_68				
Action/Comments					
Landscaping Inspector Comments: Levee slope has been landscaped. This obstructs visibility.

03/16/2012 Levee slope is heavily landscaped, retaining wall has been constructed at the levee toe.

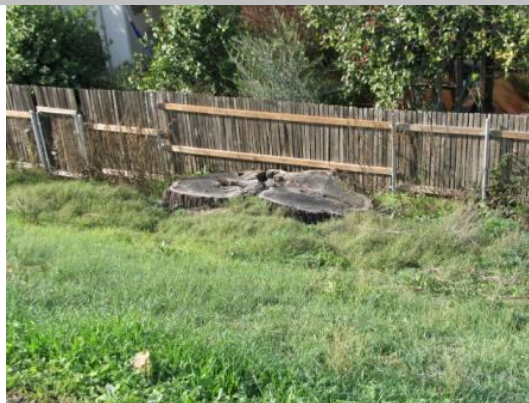
Photo 1 of 1 : SP\_2015\_NA0001\_55\_740\_20150317\_00196.jpg

LM Start	5.91	Rating **	N	Issue No.	740
LM End	5.91	Issue Type +	Ma	Location *	LS
Category	Earthen Levee			GPS Latitude/Longitude	
				Start	End
Item	Trim / Thin Trees			38.570940 °	38.570940 °
				-121.424173 °	-121.424173 °
DWR ID	DWR_NA0001_04_s _ 2012_740				
Action/Comments					
Tree stumps.					
Inspector Comments: Large stump

11/15/2011 Large stump at levee toe.

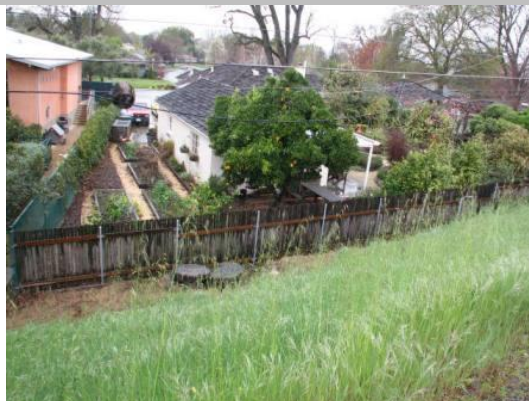
Photo 1 of 1 : SP\_2015\_NA0001\_55\_88\_20150317\_00071.jpg

LM Start	5.92	Rating **	U	Issue No.	88
LM End	5.92	Issue Type +	En	Location *	LS
Category	Earthen Levee			GPS Latitude/Longitude	
				Start	End
Item	Encroachments			38.570752 °	38.570752 °
				-121.424219 °	-121.424219 °
DWR ID	DWR_NA0001_04_f_2012_88				
Action/Comments					
Fence					
Inspector Comments: Wooden privacy fence.

03/16/2012 Wood privacy fence completely obstructs access and visibility.

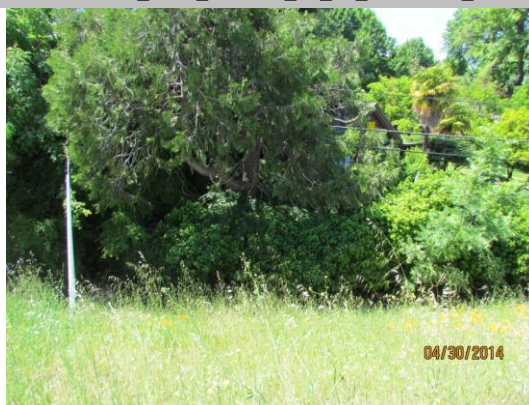
Photo 1 of 1 : SP\_2015\_NA0001\_55\_71\_20150317\_00054.jpg

LM Start	5.94	Rating **	M	Issue No.	71
LM End	5.94	Issue Type +	En	Location *	LS
Category	Earthen Levee			GPS Latitude/Longitude	
				Start	End
Item	Vegetation			38.570450 °	38.570450 °
				-121.424237 °	-121.424237 °
DWR ID	DWR_NA0001_04_s_2012_71				
Action/Comments					
Landscaping Inspector Comments: Landscaping and garden within 10-ft of the levee toe.

View of the landscaping at the landside levee toe.

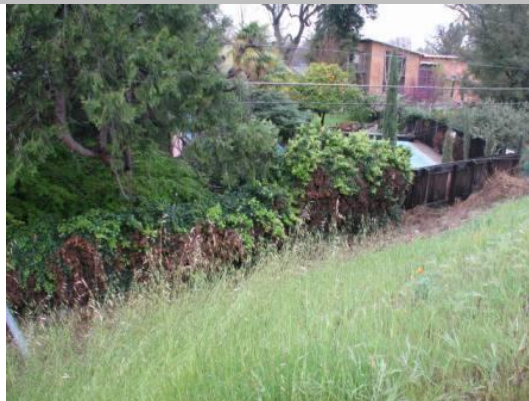
Photo 1 of 1 : SP\_2015\_NA0001\_55\_72\_20150317\_00055.jpg

LM Start	5.94	Rating **	U	Issue No.	72
LM End	5.94	Issue Type +	En	Location *	LS
Category	Earthen Levee			GPS Latitude/Longitude	
				Start	End
Item	Encroachments			38.570391 °	38.570391 °
				-121.424227 °	-121.424227 °
DWR ID	DWR_NA0001_04_s_2012_72				
Action/Comments					
Fence					
Inspector Comments: Wood fence and landscaping within 10-ft of the levee toe obstructs visibility.

03/16/2012 Wood privacy fence completely obstructs access and visibility.

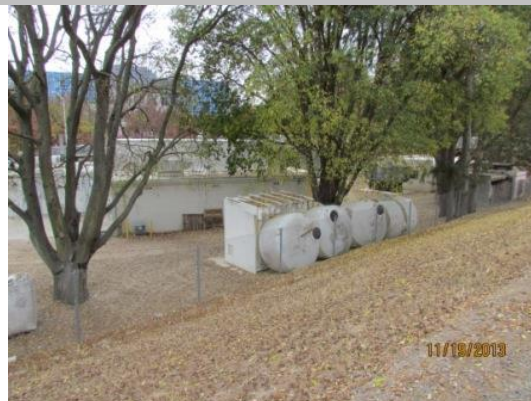
Photo 1 of 1 : SP\_2015\_NA0001\_55\_185\_20150317\_00161.jpg

LM Start	6.60	Rating **	M	Issue No.	185
LM End	6.60	Issue Type +	En	Location *	LS
Category	Earthen Levee			GPS Latitude/Longitude	
				Start	End
Item	Encroachments			38.561448 °	38.561448 °
				-121.421071 °	-121.421071 °
DWR ID	DWR_NA0001_04_f_2013_185				
Action/Comments					
Tank					
Inspector Comments: 5 water tanks and storage shed within 10 feet of landside levee toe.

View of the water tanks stored at the landside levee toe.

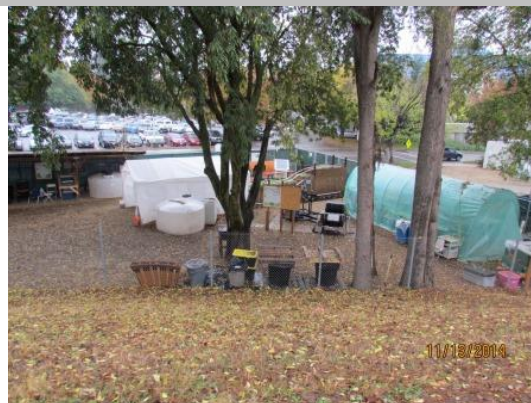
Photo 1 of 1 : SP\_2015\_NA0001\_55\_51\_20150317\_00040.jpg

LM Start	6.62	Rating **	M	Issue No.	51
LM End	6.62	Issue Type +	En	Location *	LS
Category	Earthen Levee			GPS Latitude/Longitude	
				Start	End
Item	Encroachments			38.561117 °	38.561117 °
				-121.420749 °	-121.420749 °
DWR ID	DWR_NA0001_04_f_2013_51				
Action/Comments					
Material					
Inspector Comments: Pipe and other material stored within 10 feet of landside levee toe.

View of the material stored at the landside levee toe.

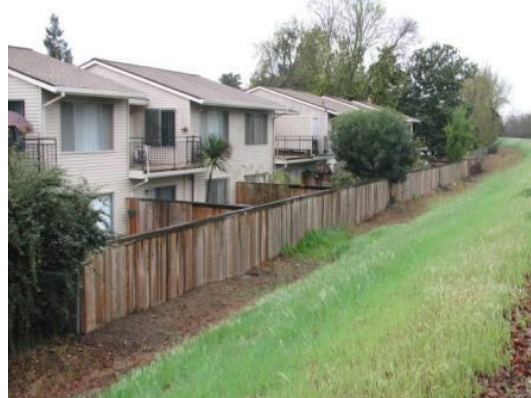
Photo 1 of 1 : SP\_2015\_NA0001\_55\_74\_20150317\_00057.jpg

Action/Comments					
Fence Inspector Comments: Wooden privacy fence for seven apartment units is within 10-ft of levee toe and obstructs access and visibility.

03/16/2012 Wood privacy fence completely obstructs access and visibility.

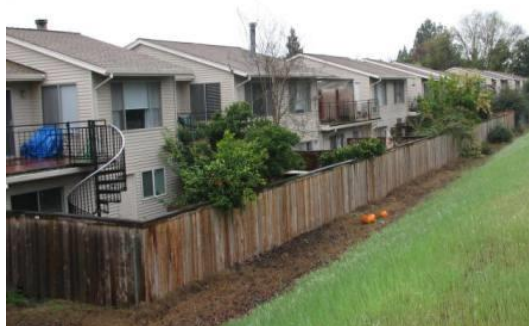
Photo 1 of 1 : SP\_2015\_NA0001\_55\_75\_20150317\_00058.jpg

LM Start	7.69	Rating **	U	Issue No.	75
LM End	7.72	Issue Type +	En	Location *	LS
Category	Earthen Levee			GPS Latitude/Longitude	
				Start	End
Item	Encroachments			38.559230 °	38.559261 °
				-121.402708 °	-121.402219 °
DWR ID	DWR_NA0001_04_s_2012_75				
Action/Comments					
Fence					
Inspector Comments: Wooden privacy fence for seven apartment units is within 10-ft of levee toe and obstructs access and visibility.

03/16/2012 Wood privacy fence completely obstructs access and visibility.

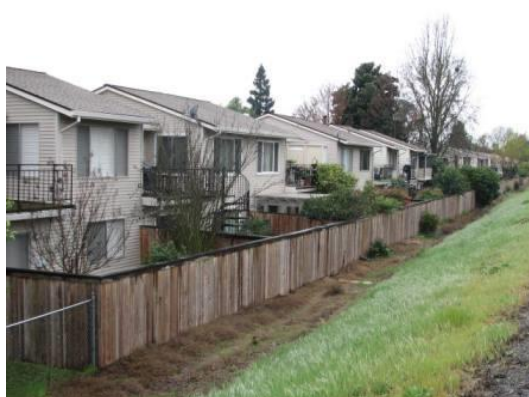
Photo 1 of 1 : SP\_2015\_NA0001\_55\_77\_20150317\_00060.jpg

LM Start	7.78	Rating **	U	Issue No.	77
LM End	7.80	Issue Type +	En	Location *	LS
Category	Earthen Levee			GPS Latitude/Longitude	
				Start	End
Item	Encroachments			38.559330 °	38.559366 °
				-121.401162 °	-121.400683 °
DWR ID	DWR_NA0001_04_s_2012_77				
Action/Comments					
Fence					
Inspector Comments: Wooden privacy fence for seven apartment units is within 10-ft of levee toe and obstructs access and visibility.

03/16/2012 Wood privacy fence completely obstructs access and visibility.

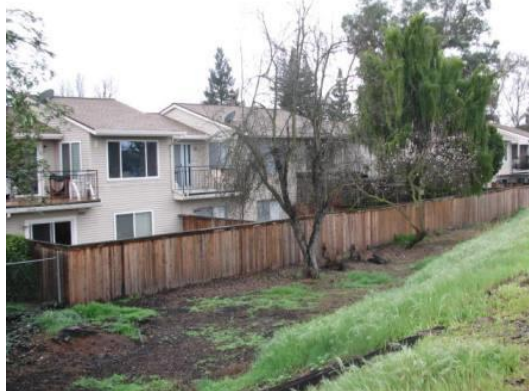
Photo 1 of 1 : SP\_2015\_NA0001\_55\_78\_20150317\_00061.jpg

LM Start	7.82	Rating **	U	Issue No.	78
LM End	7.84	Issue Type +	En	Location *	LS
Category	Earthen Levee			GPS Latitude/Longitude	
				Start	End
Item	Encroachments			38.559379 °	38.559435 °
				-121.400354 °	-121.399944 °
DWR ID	DWR_NA0001_04_s _ 2012_78				
Action/Comments					
Fence					
Inspector Comments: Wooden privacy fence for seven apartment units is within 10-ft of levee toe and obstructs access and visibility.

03/16/2012 Wood privacy fence completely obstructs access and visibility.

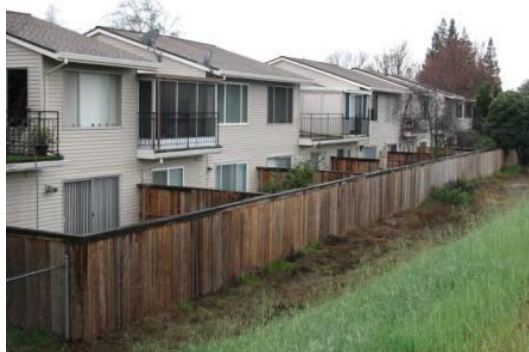
Photo 1 of 1 : SP\_2015\_NA0001\_55\_79\_20150317\_00062.jpg

LM Start	7.86	Rating **	U	Issue No.	79
LM End	7.88	Issue Type +	En	Location *	LS
Category	Earthen Levee			GPS Latitude/Longitude	
				Start	End
Item	Encroachments			38.559514 °	38.559643 °
				-121.399700 °	-121.399248 °
DWR ID	DWR_NA0001_04_s _ 2012_79				
Action/Comments					
Fence					
Inspector Comments: Wooden privacy fence for seven apartment units is within 10-ft of levee toe and obstructs access and visibility.

03/16/2012 Wood privacy fence completely obstructs access and visibility.

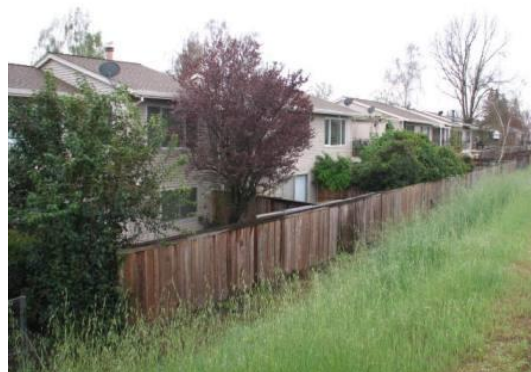
Photo 1 of 1 : SP\_2015\_NA0001\_55\_80\_20150317\_00063.jpg

LM Start	7.90	Rating **	U	Issue No.	80
LM End	7.93	Issue Type +	En	Location *	LS
Category	Earthen Levee			GPS Latitude/Longitude	
				Start	End
Item	Encroachments			38.559753 °	38.559911 °
				-121.398982 °	-121.398506 °
DWR ID	DWR_NA0001_04_s _ 2012_80				
Action/Comments					
Fence					
Inspector Comments: Wooden privacy fence for seven apartment units is within 10-ft of levee toe and obstructs access and visibility.

03/16/2012 Wood privacy fence completely obstructs access and visibility.

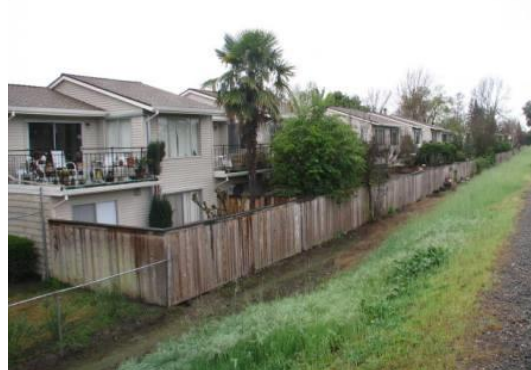
Photo 1 of 1 : SP\_2015\_NA0001\_55\_224\_20150317\_00181.jpg

LM Start	7.94	Rating **	U	Issue No.	224
LM End	7.97	Issue Type +	En	Location *	LS
Category	Earthen Levee			GPS Latitude/Longitude	
				Start	End
Item	Encroachments			38.559994 °	38.560185 °
				-121.398318 °	-121.397845 °
DWR ID	DWR_NA0001_04_s _ 2012_224				
Action/Comments					
Fence					
Inspector Comments: Wooden privacy fence for seven apartment units is within 10-ft of levee toe and obstructs access and visibility.

03/16/2012 Wood privacy fence completely obstructs access and visibility.

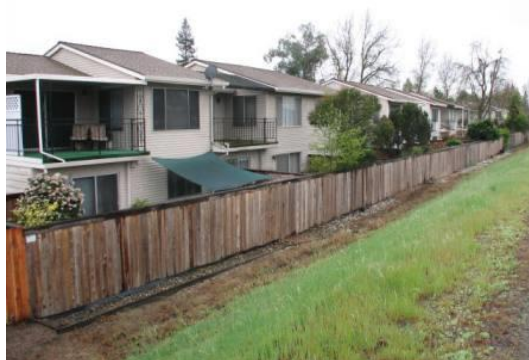
Photo 1 of 1 : SP\_2015\_NA0001\_55\_81\_20150317\_00064.jpg

LM Start	7.98	Rating **	U	Issue No.	81
LM End	8.00	Issue Type +	En	Location *	LS
Category	Earthen Levee			GPS Latitude/Longitude	
				Start	End
Item	Encroachments			38.560281 °	38.560435 °
				-121.397604 °	-121.397239 °
DWR ID	DWR_NA0001_04_s_2012_81				
Action/Comments					
Fence					
Inspector Comments: Wooden privacy fence for seven apartment units is within 10-ft of levee toe and obstructs access and visibility.

03/16/2012 Wood privacy fence completely obstructs access and visibility.

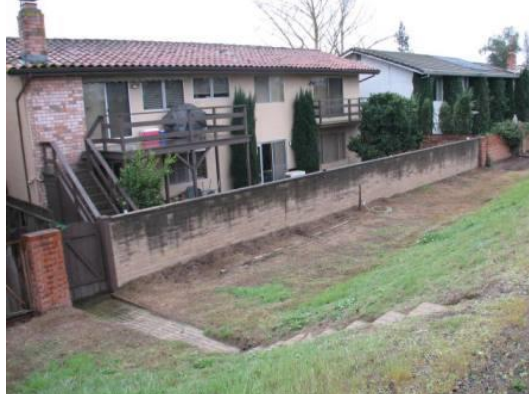
Photo 1 of 1 : SP\_2015\_NA0001\_55\_83\_20150317\_00066.jpg

LM Start	8.04	Rating **	U	Issue No.	83
LM End	8.04	Issue Type +	En	Location *	LS
Category	Earthen Levee			GPS Latitude/Longitude	
				Start	End
Item	Encroachments			38.560647 °	38.560647 °
				-121.396660 °	-121.396660 °
DWR ID	DWR_NA0001_04_s_2012_83				
Action/Comments					
Fence					
Inspector Comments: Brick fence is within 10-ft of levee toe and obstructs access and visibility.

03/16/2012 Brick wall completely obstructs access and visibility.

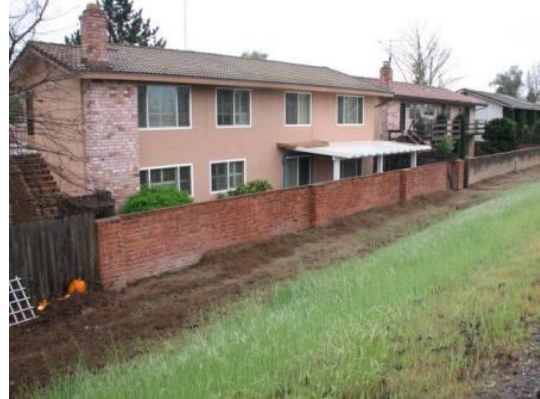
Photo 1 of 1 : SP\_2015\_NA0001\_55\_84\_20150317\_00067.jpg

LM Start	8.05	Rating **	U	Issue No.	84
LM End	8.05	Issue Type +	En	Location *	LS
Category	Earthen Levee			GPS Latitude/Longitude	
				Start	End
Item	Encroachments			38.560728 °	38.560728 °
				-121.396471 °	-121.396471 °
DWR ID	DWR_NA0001_04_s _ 2012_84				
Action/Comments					
Fence					
Inspector Comments: Brick fence is within 10-ft of levee toe and obstructs access and visibility.

03/16/2012 Brick wall completely obstructs access and visibility.

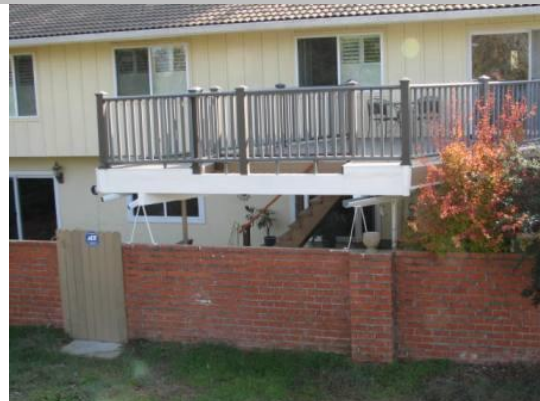
Photo 1 of 1 : SP\_2015\_NA0001\_55\_745\_20150317\_00198.jpg

LM Start	8.06	Rating **	A/W	Issue No.	745
LM End	8.06	Issue Type +	Ma	Location *	LS
Category	Earthen Levee			GPS Latitude/Longitude	
				Start	End
Item	Encroachments			38.560830 °	38.560830 °
				-121.396232 °	-121.396232 °
DWR ID	DWR_NA0001_04_s _ 2012_745				
Action/Comments					
Urban					
Inspector Comments: Drains direct gutter flow onto levee toe.

11/15/2011 Gutter drains that are suspended from the balcony direct flow onto the levee toe.

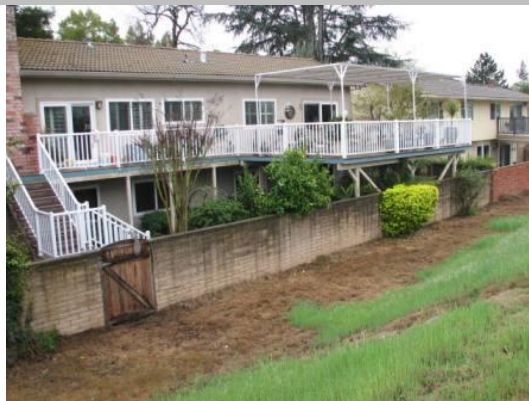
Photo 1 of 1 : SP\_2015\_NA0001\_55\_86\_20150317\_00069.jpg

LM Start	8.08	Rating **	U	Issue No.	86
LM End	8.08	Issue Type +	En	Location *	LS
Category	Earthen Levee			GPS Latitude/Longitude	
				Start	End
Item	Encroachments			38.560907 °	38.560907 °
				-121.396043 °	-121.396043 °
DWR ID	DWR_NA0001_04_s_2012_86				
Action/Comments					
Fence					
Inspector Comments: Brick fence is within 10-ft of levee toe and obstructs access and visibility.

03/16/2012 Brick wall completely obstructs access and visibility.

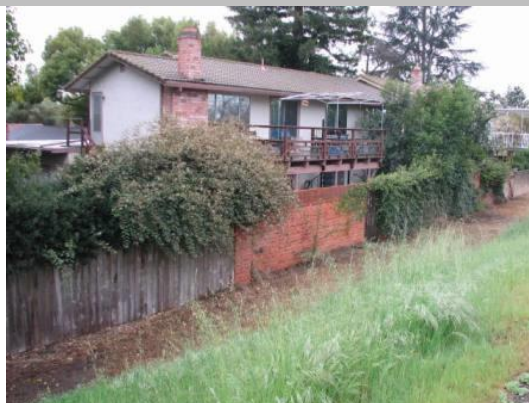
Photo 1 of 1 : SP\_2015\_NA0001\_55\_87\_20150317\_00070.jpg

LM Start	8.09	Rating **	U	Issue No.	87
LM End	8.09	Issue Type +	En	Location *	LS
Category	Earthen Levee			GPS Latitude/Longitude	
				Start	End
Item	Encroachments			38.561008 °	38.561008 °
				-121.395817 °	-121.395817 °
DWR ID	DWR_NA0001_04_s_2012_87				
Action/Comments					
Fence					
Inspector Comments: Brick fence is within 10-ft of levee toe and obstructs access and visibility.

03/16/2012 Brick wall completely obstructs access and visibility.

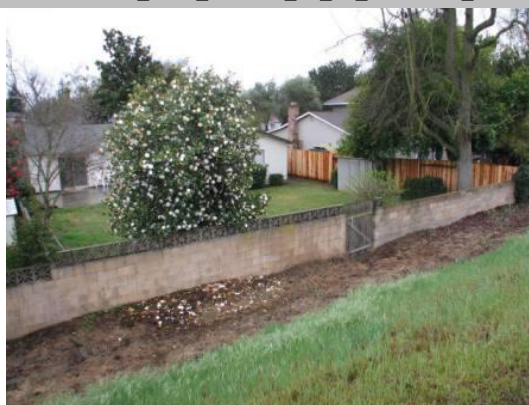
Photo 1 of 1 : SP\_2015\_NA0001\_55\_90\_20150317\_00073.jpg

LM Start	8.17	Rating **	U	Issue No.	90
LM End	8.17	Issue Type +	En	Location *	LS
Category	Earthen Levee			GPS Latitude/Longitude	
				Start	End
Item	Encroachments			38.561544 °	38.561544 °
				-121.394494 °	-121.394494 °
DWR ID	DWR_NA0001_04_s_2012_90				
Action/Comments					
Fence					
Inspector Comments: Cement block fence within 10-ft of the levee toe.

03/16/2012 Cinder block wall completely obstructs access and visibility.

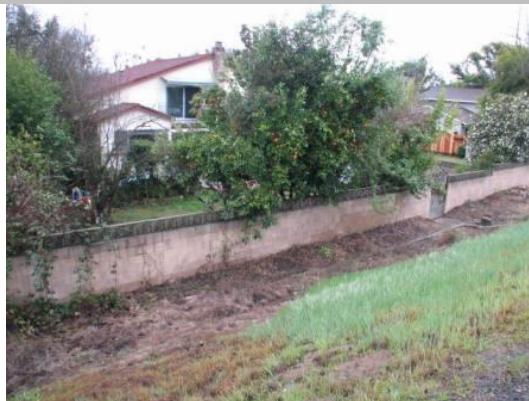
Photo 1 of 1 : SP\_2015\_NA0001\_55\_91\_20150317\_00074.jpg

LM Start	8.18	Rating **	U	Issue No.	91
LM End	8.18	Issue Type +	En	Location *	LS
Category	Earthen Levee			GPS Latitude/Longitude	
				Start	End
Item	Encroachments			38.561593 °	38.561593 °
				-121.394315 °	-121.394315 °
DWR ID	DWR_NA0001_04_s_2012_91				
Action/Comments					
Fence					
Inspector Comments: Concrete block fence and landscaping within 10-ft of levee toe obstructs access and visibility.

03/16/2012 Cinder block wall completely obstructs access and visibility.

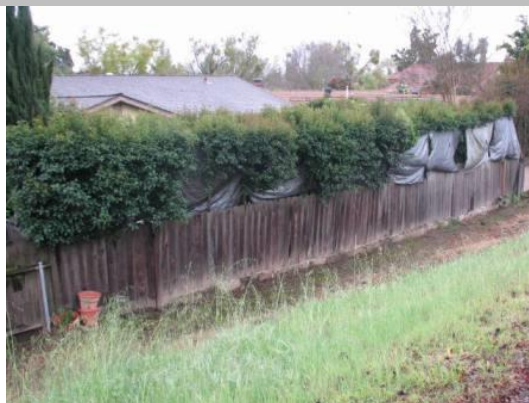
Photo 1 of 1 : SP\_2015\_NA0001\_55\_93\_20150317\_00076.jpg

LM Start	8.21	Rating **	U	Issue No.	93
LM End	8.21	Issue Type +	En	Location *	LS
Category	Earthen Levee			GPS Latitude/Longitude	
				Start	End
Item	Encroachments			38.561750 °	38.561750 °
				-121.393917 °	-121.393917 °
DWR ID	DWR_NA0001_04_s _ 2012_93				
Action/Comments					
Fence					
Inspector Comments: Wooden fence, strung tarps, and landscaping within 10-ft of levee toe obstructs access and visibility.

03/16/2012 Wood privacy fence completely obstructs access and visibility.

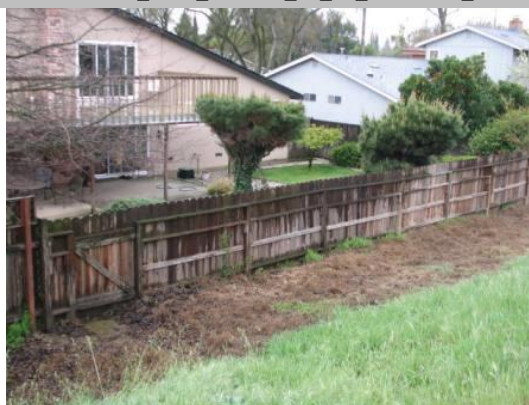
Photo 1 of 1 : SP\_2015\_NA0001\_55\_97\_20150317\_00080.jpg

LM Start	8.24	Rating **	U	Issue No.	97
LM End	8.24	Issue Type +	En	Location *	LS
Category	Earthen Levee			GPS Latitude/Longitude	
				Start	End
Item	Encroachments			38.561986 °	38.561986 °
				-121.393343 °	-121.393343 °
DWR ID	DWR_NA0001_04_s _ 2012_97				
Action/Comments					
Fence					
Inspector Comments: Wood privacy fence within 10-ft of levee toe obstructs access and visibility.

03/16/2012 Wood privacy fence completely obstructs access and visibility.

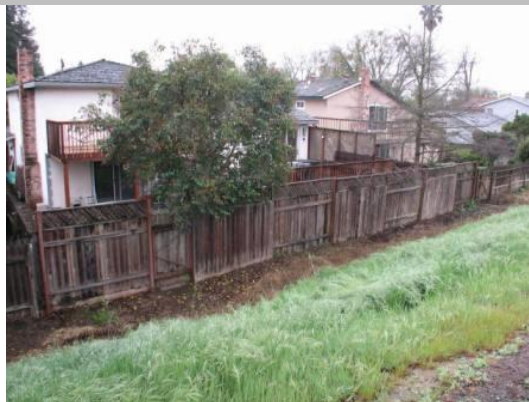
Photo 1 of 1 : SP\_2015\_NA0001\_55\_98\_20150317\_00081.jpg

LM Start	8.25	Rating **	U	Issue No.	98
LM End	8.25	Issue Type +	En	Location *	LS
Category	Earthen Levee			GPS Latitude/Longitude	
				Start	End
Item	Encroachments			38.562054 °	38.562054 °
				-121.393190 °	-121.393190 °
DWR ID	DWR_NA0001_04_s _ 2012_98				
Action/Comments					
Fence					
Inspector Comments: Wood privacy fence within 10-ft of levee toe obstructs access and visibility.

03/16/2012 Wood privacy fence completely obstructs access and visibility.

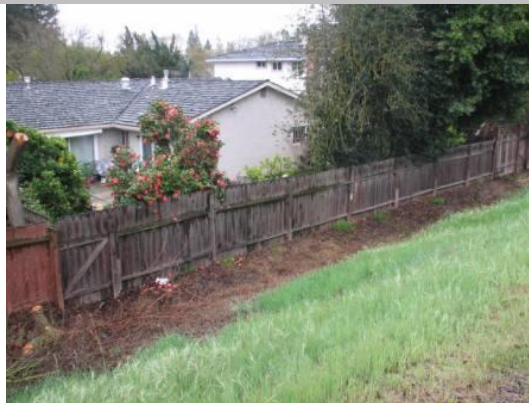
Photo 1 of 1 : SP\_2015\_NA0001\_55\_99\_20150317\_00082.jpg

LM Start	8.26	Rating **	U	Issue No.	99
LM End	8.26	Issue Type +	En	Location *	LS
Category	Earthen Levee			GPS Latitude/Longitude	
				Start	End
Item	Encroachments			38.562120 °	38.562120 °
				-121.392983 °	-121.392983 °
DWR ID	DWR_NA0001_04_s _ 2012_99				
Action/Comments					
Fence					
Inspector Comments: Wood privacy fence within 10-ft of levee toe obstructs access and visibility.

03/16/2012 Wood privacy fence completely obstructs access and visibility.

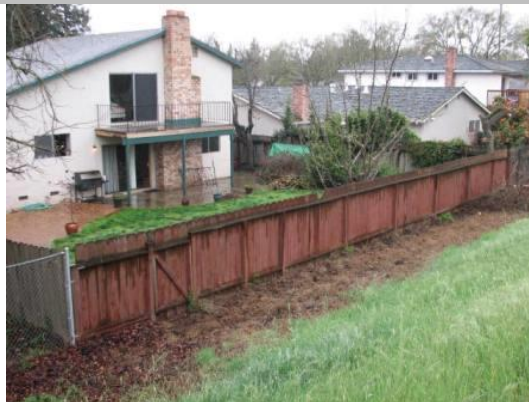
Photo 1 of 1 : SP\_2015\_NA0001\_55\_100\_20150317\_00083.jpg

LM Start	8.27	Rating **	U	Issue No.	100
LM End	8.27	Issue Type +	En	Location *	LS
Category	Earthen Levee			GPS Latitude/Longitude	
				Start	End
Item	Encroachments			38.562182 °	38.562182 °
				-121.392778 °	-121.392778 °
DWR ID	DWR_NA0001_04_s _ 2012_100				
Action/Comments					
Fence					
Inspector Comments: Wood privacy fence within 10-ft of levee toe obstructs access and visibility.

03/16/2012 Wood privacy fence completely obstructs access and visibility.

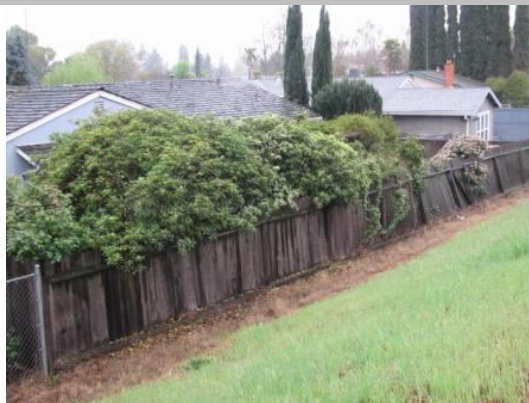
Photo 1 of 1 : SP\_2015\_NA0001\_55\_104\_20150317\_00087.jpg

LM Start	8.41	Rating **	U	Issue No.	104
LM End	8.41	Issue Type +	En	Location *	LS
Category	Earthen Levee			GPS Latitude/Longitude	
				Start	End
Item	Encroachments			38.563108 °	38.563108 °
				-121.390452 °	-121.390452 °
DWR ID	DWR_NA0001_04_s_2012_104				
Action/Comments					
Fence					
Inspector Comments: Wood privacy fence within 10-ft of levee toe obstructs access and visibility.

03/16/2012 Wood privacy fence completely obstructs access and visibility.

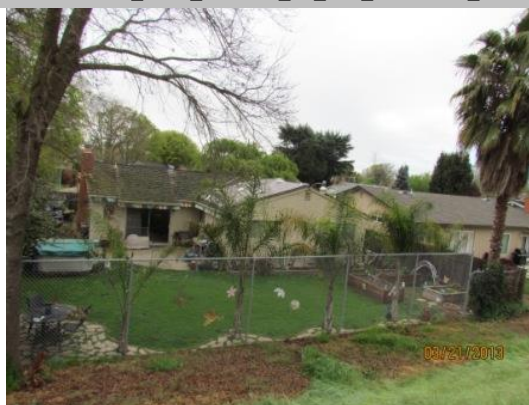
Photo 1 of 1 : SP\_2015\_NA0001\_55\_105\_20150317\_00088.jpg

LM Start	8.44	Rating **	M	Issue No.	105
LM End	8.44	Issue Type +	En	Location *	LS
Category	Earthen Levee			GPS Latitude/Longitude	
				Start	End
Item	Vegetation			38.563238 °	38.563238 °
				-121.390073 °	-121.390073 °
DWR ID	DWR_NA0001_04_s_2012_105				
Action/Comments					
Landscaping Inspector Comments: Palms planted within 10-ft of the levee toe.

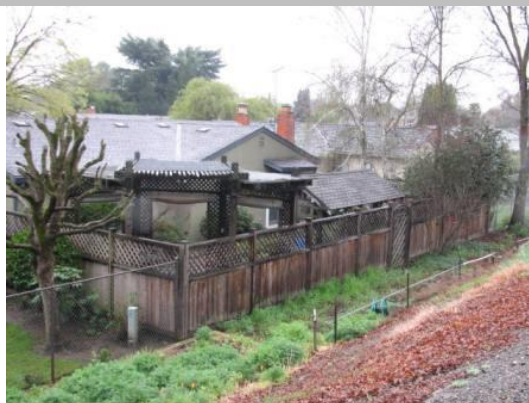
Photo 1 of 1 : SP\_2015\_NA0001\_55\_106\_20150317\_00089.jpg

LM Start	8.45	Rating **	U	Issue No.	106
LM End	8.45	Issue Type +	En	Location *	LS
Category	Earthen Levee			GPS Latitude/Longitude	
				Start	End
Item	Encroachments			38.563308 °	38.563308 °
				-121.389885 °	-121.389885 °
DWR ID	DWR_NA0001_04_s_2012_106				
Action/Comments					
Fence					
Inspector Comments: Wood privacy fence within 10-ft of levee toe obstructs access and visibility. Block wall built into the levee.

03/16/2012 Wood privacy fence completely obstructs access and visibility.

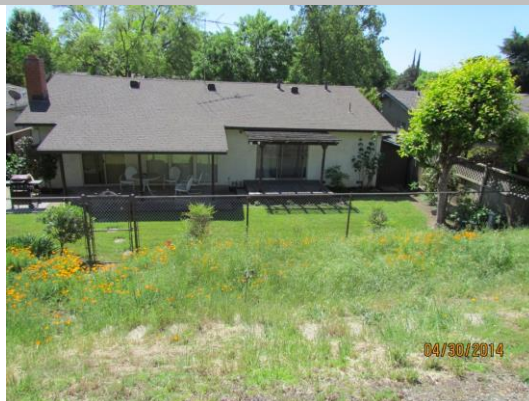
Photo 1 of 1 : SP\_2015\_NA0001\_55\_246\_20150317\_00192.jpg

LM Start	8.46	Rating **	M	Issue No.	246
LM End	8.46	Issue Type +	En	Location *	LS
Category	Earthen Levee			GPS Latitude/Longitude	
				Start	End
Item	Encroachments			38.563434 °	38.563434 °
				-121.389675 °	-121.389675 °
DWR ID	DWR_NA0001_04_s_2014_246				
Action/Comments					
Retaining Wall					
Inspector Comments: Retaining wall and irrigation at landside levee toe.

View of the irrigation and retaining wall at the landside levee toe.

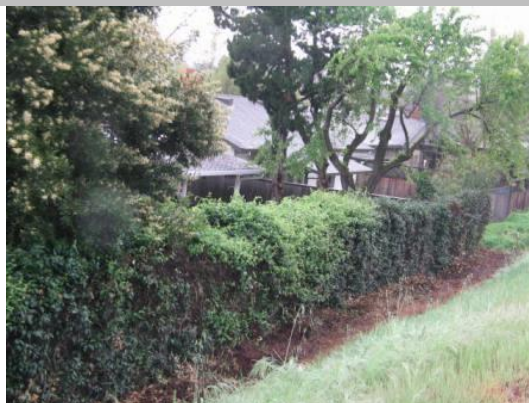
Photo 1 of 1 : SP\_2015\_NA0001\_55\_107\_20150317\_00090.jpg

LM Start	8.47	Rating **	U	Issue No.	107
LM End	8.47	Issue Type +	En	Location *	LS
Category	Earthen Levee			GPS Latitude/Longitude	
				Start	End
Item	Vegetation			38.563511 °	38.563511 °
				-121.389509 °	-121.389509 °
DWR ID	DWR_NA0001_04_s_2012_107				
Action/Comments					
Landscaping

03/16/2012 Landscaping obstructs visibility and access.

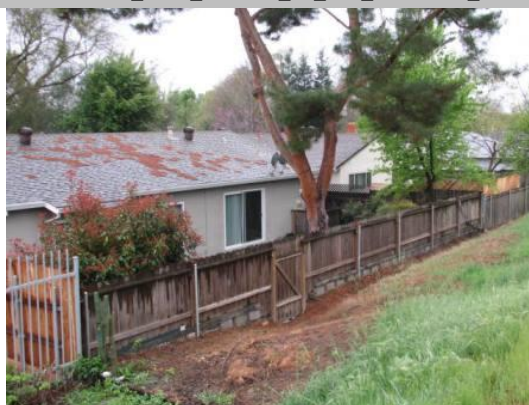
Photo 1 of 1 : SP\_2015\_NA0001\_55\_110\_20150317\_00093.jpg

LM Start	8.51	Rating **	U	Issue No.	110
LM End	8.51	Issue Type +	En	Location *	LS
Category	Earthen Levee			GPS Latitude/Longitude	
				Start	End
Item	Encroachments			38.563732 °	38.563732 °
				-121.388930 °	-121.388930 °
DWR ID	DWR_NA0001_04_s_2012_110				
Action/Comments					
Fence					
Inspector Comments: Wood privacy fence within 10-ft of levee toe obstructs access and visibility.

03/16/2012 Wood privacy fence completely obstructs access and visibility.

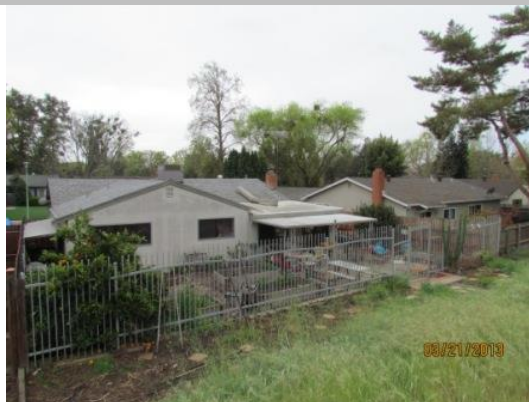
Photo 1 of 1 : SP\_2015\_NA0001\_55\_226\_20150317\_00183.jpg

LM Start	8.52	Rating **	M	Issue No.	226
LM End	8.52	Issue Type +	En	Location *	LS
Category	Earthen Levee			GPS Latitude/Longitude	
				Start	End
Item	Vegetation			38.563793 °	38.563793 °
				-121.388758 °	-121.388758 °
DWR ID	DWR_NA0001_04_s_2012_226				
Action/Comments					
Landscaping					
Inspector Comments: Garden, trees and cactus planted against the levee toe.

View of landscaping at the levee toe.

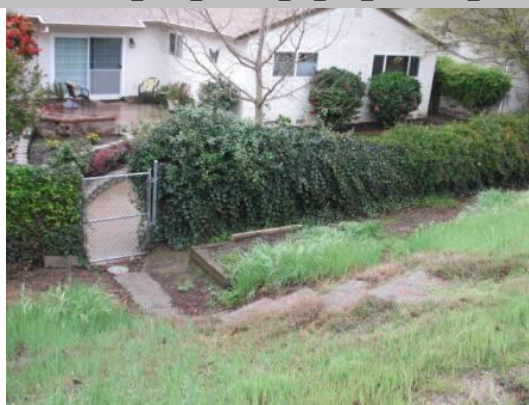
Photo 1 of 1 : SP\_2015\_NA0001\_55\_113\_20150317\_00096.jpg

LM Start	8.54	Rating **	U	Issue No.	113
LM End	8.54	Issue Type +	En	Location *	LS
Category	Earthen Levee			GPS Latitude/Longitude	
				Start	End
Item	Vegetation			38.563877 °	38.563877 °
				-121.388343 °	-121.388343 °
DWR ID	DWR_NA0001_04_s_2012_113				
Action/Comments					
Landscaping

03/16/2012 Landscaping on chainlink fence blocks visibility and access.

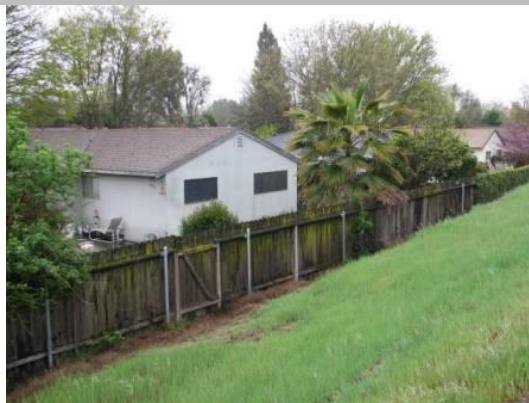
Photo 1 of 1 : SP\_2015\_NA0001\_55\_115\_20150317\_00098.jpg

LM Start	8.58	Rating **	U	Issue No.	115
LM End	8.58	Issue Type +	En	Location *	LS
Category	Earthen Levee			GPS Latitude/Longitude	
				Start	End
Item	Encroachments			38.564047 °	38.564047 °
				-121.387743 °	-121.387743 °
DWR ID	DWR_NA0001_04_s _ 2012_115				
Action/Comments					
Fence					
Inspector Comments: Wood privacy fence and 2-story play house within 10-ft of levee toe obstructs access and visibility.

03/16/2012 Wood privacy fence completely obstructs access and visibility.

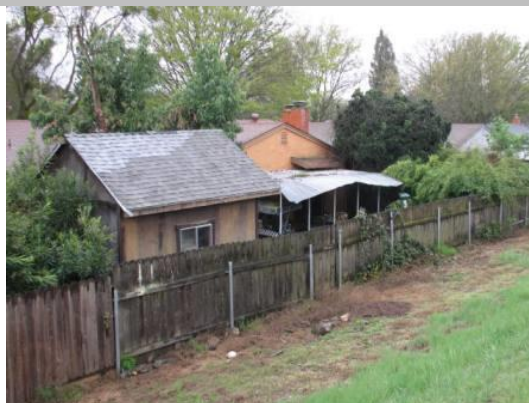
Photo 1 of 1 : SP\_2015\_NA0001\_55\_117\_20150317\_00100.jpg

LM Start	8.58	Rating **	U	Issue No.	117
LM End	8.58	Issue Type +	En	Location *	LS
Category	Earthen Levee			GPS Latitude/Longitude	
				Start	End
Item	Encroachments			38.564033 °	38.564033 °
				-121.387572 °	-121.387572 °
DWR ID	DWR_NA0001_04_s _ 2012_117				
Action/Comments					
Fence					
Inspector Comments: Wood privacy fence and wood out building within 10-ft of levee toe obstructs access and visibility.

03/16/2012 Wood privacy fence completely obstructs access and visibility.
